Contract #: 04-0120F4Cty: SF/ALA Rte: 80 PM: 13.2/13.9File #: 69.28**WELDING INSPECTION REPORT****Resident Engineer:**Pursell, Gary**Address:** 333 Burma Road**City:** Oakland, CA 94607**Report No:** WIR-002540**Date Inspected:** 20-May-2008**Project Name:** SAS Superstructure**OSM Arrival Time:** 1400**Prime Contractor:** American Bridge/Fluor Enterprises, a JV**OSM Departure Time:** 2300**Contractor:** Zhenhua Port Machinery Company, Ltd (ZPMC), Changxing Island **Location:** Shanghai, China

Bridge No: 34-0006**Component:** OBG side and bottom panels and tower skin p**Summary of Items Observed:**

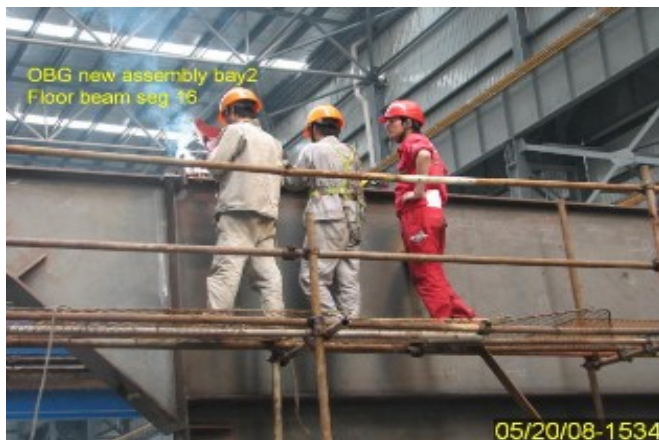
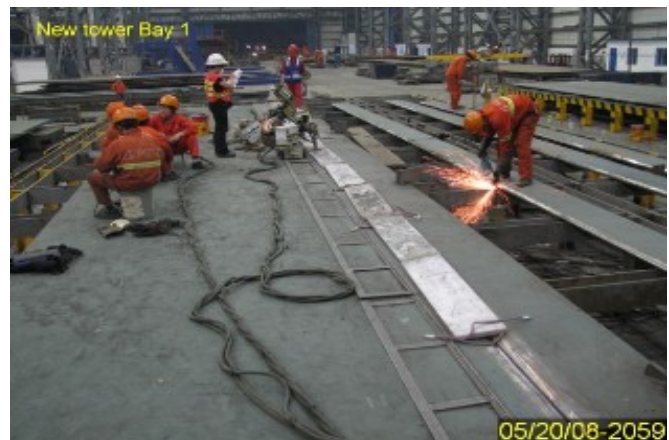
Other general observations in the New Tower bays include ZPMC tack welding tower skin plates, weld bevel preparation, flame straightening, CNC parts cutting and grinding.
